# SERVICE LETTER

## SL-AG-136

### Control Stick Wiring Harness Inspection

Affected Aircraft Models	Serial Number Range
All S2R	ALL

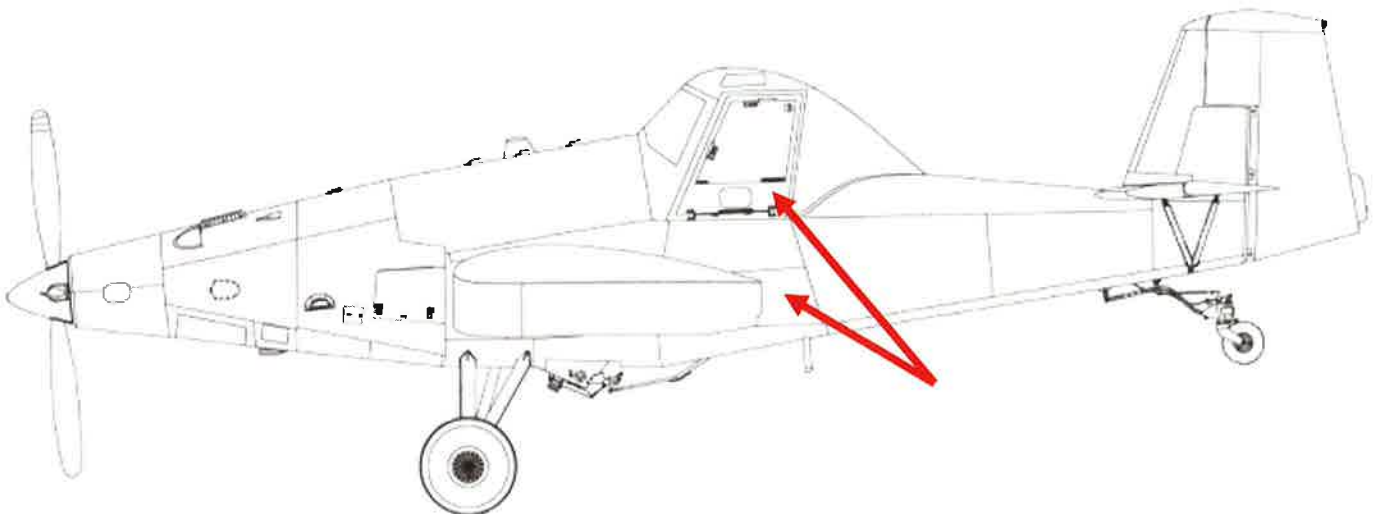
***Figure 3-1 – Single Cockpit S2R-510 Used For Reference Only***

1. Enter cockpit through cockpit door for access to the control stick dust cover base. (Reference Figures 3-1 & 4-2).
2. Remove LH lower panel below cockpit and above aft wing fairing for access to the canon plug. (Reference Figures 3-1 & 4-1)

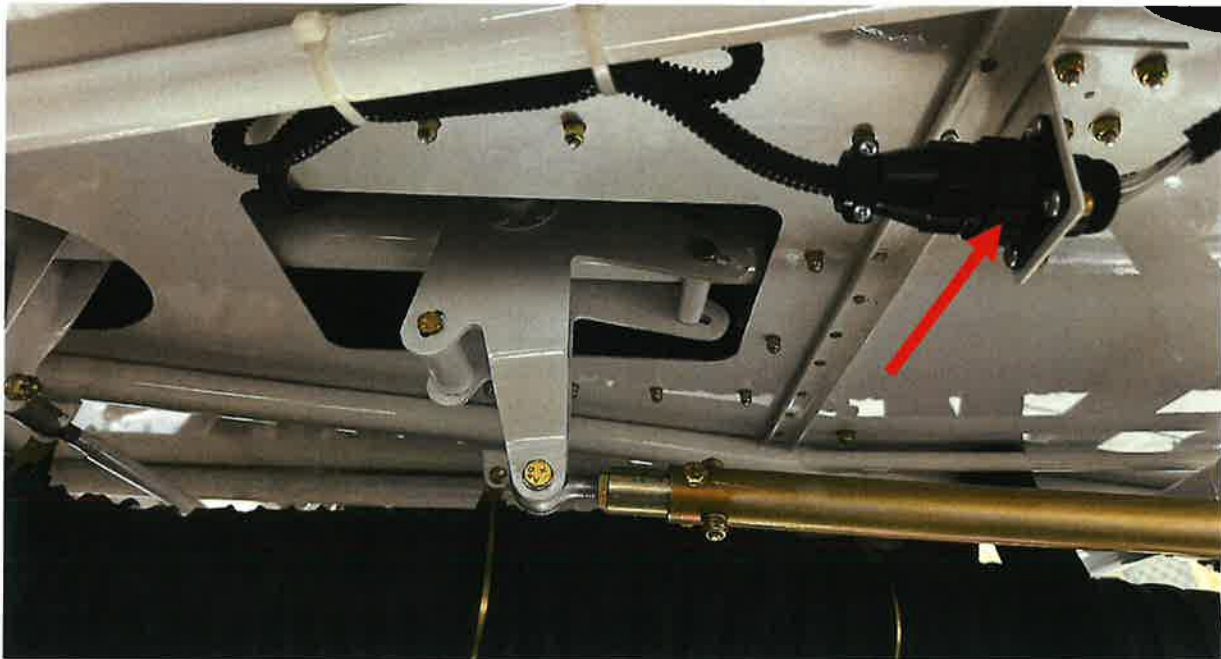
*Figure 4-1*

1. Disconnect cannon plug, located underneath the LH side of the cockpit. (Reference Figure 4-1)

5. Deburr and prep area where paint was removed from trimming and grinding.
6. Refinish bare metal with appropriate primer and paint and allow to dry.
7. Install the control stick wiring harness as it was previously installed.
8. Reinstall the control stick grip.
9. Reinstall the control stick to the torque tube and retorque the bolts (100-140 inch/lbs. / 8.3 – 11.6 ft/lbs.). (Reference Figure 6-1)
10. Reroute and reconnect wiring harness canon plug. (Reference Figure 4-1)

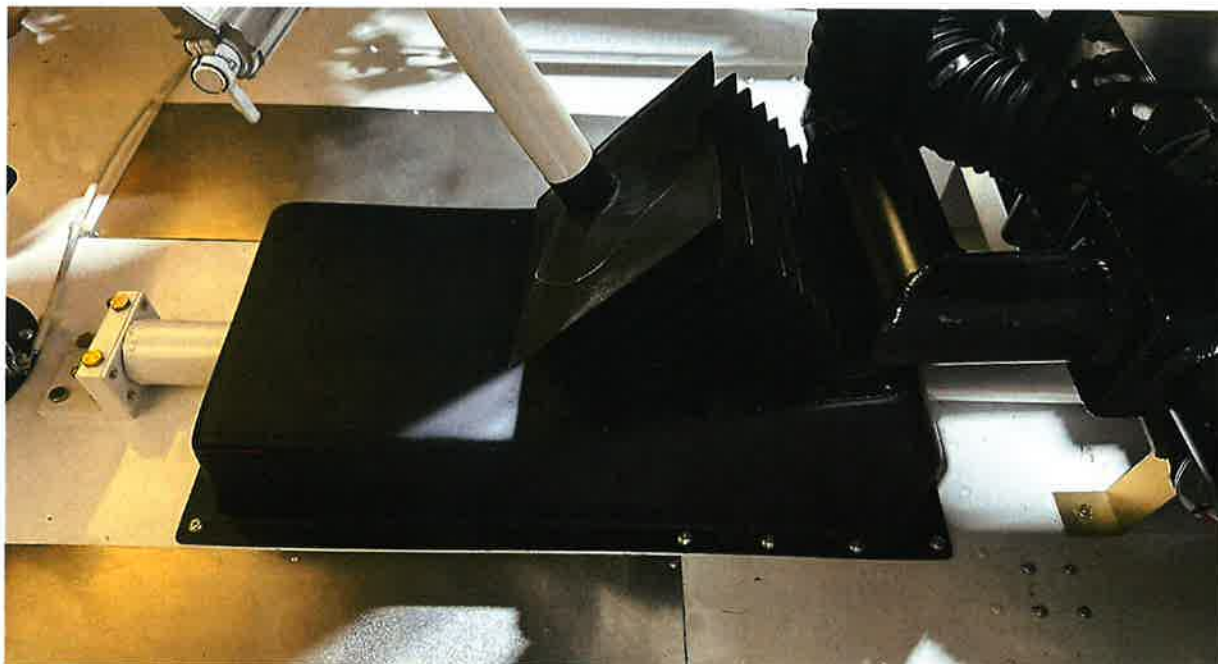
*Figure 4-2*

2. Locate and remove the screws from the control stick base within the cockpit and save for reinstallation. (Reference Figure 4-2)

11. Check for full control stick movement in all directions no longer pinching or cutting wires.
12. Reinstall stick base with screws to floorboard. (Reference Figure 4-2)
13. Inspect the belly area and remove all foreign objects and debris (FOD).
14. Reinstall the panels that were removed.

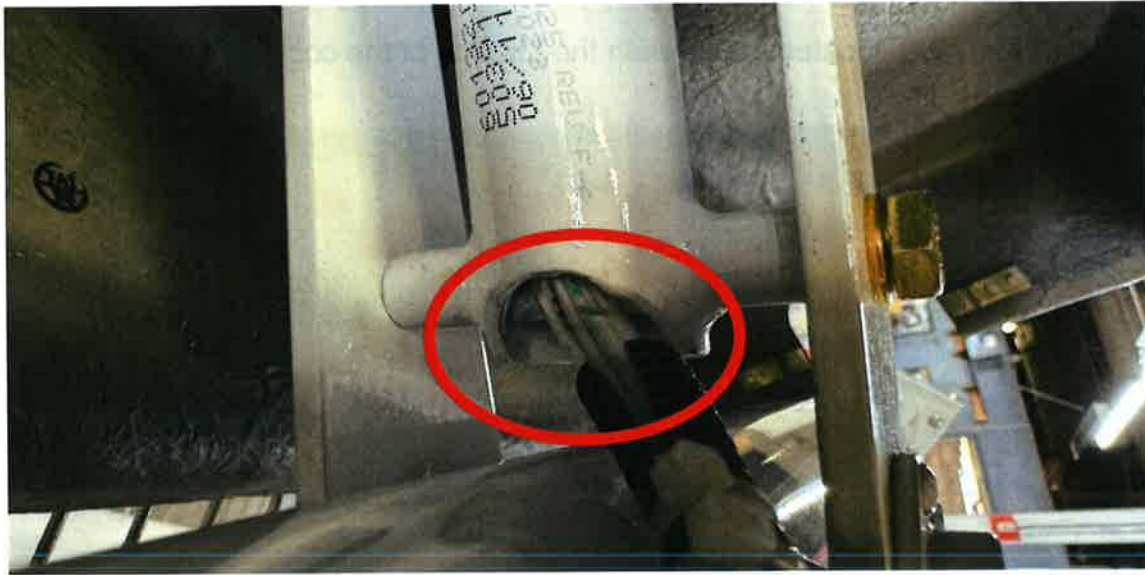
**Figure 4-3**

Thrush has been notified by one or more operator(s) that some of the control stick wiring harnesses have been damaged due to routing and rigging variations on installation and after some modifications and maintenance.

3. Inspect the wire harness at the base of the control stick. (Reference Figure 4-3)

If wires are damaged, notify Thrush Aircraft, LLC by sending an email to [support@thrushaircraft.com](mailto:support@thrushaircraft.com) and speak with someone about ordering a replacement control stick wiring harness.

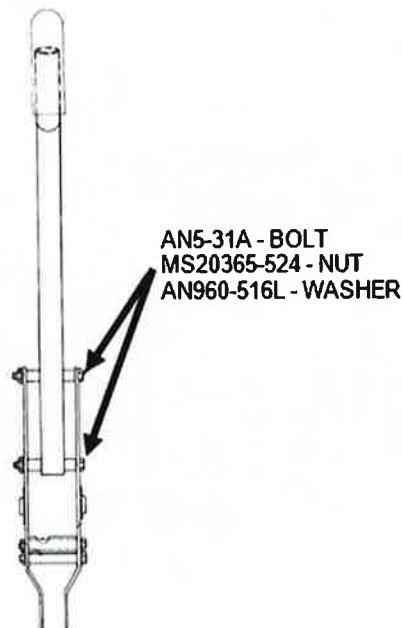
**Figure 6-1**

1. Remove lateral stick bolts that connect the control stick assembly to the control stick torque tube. (Reference Figure 6-1)

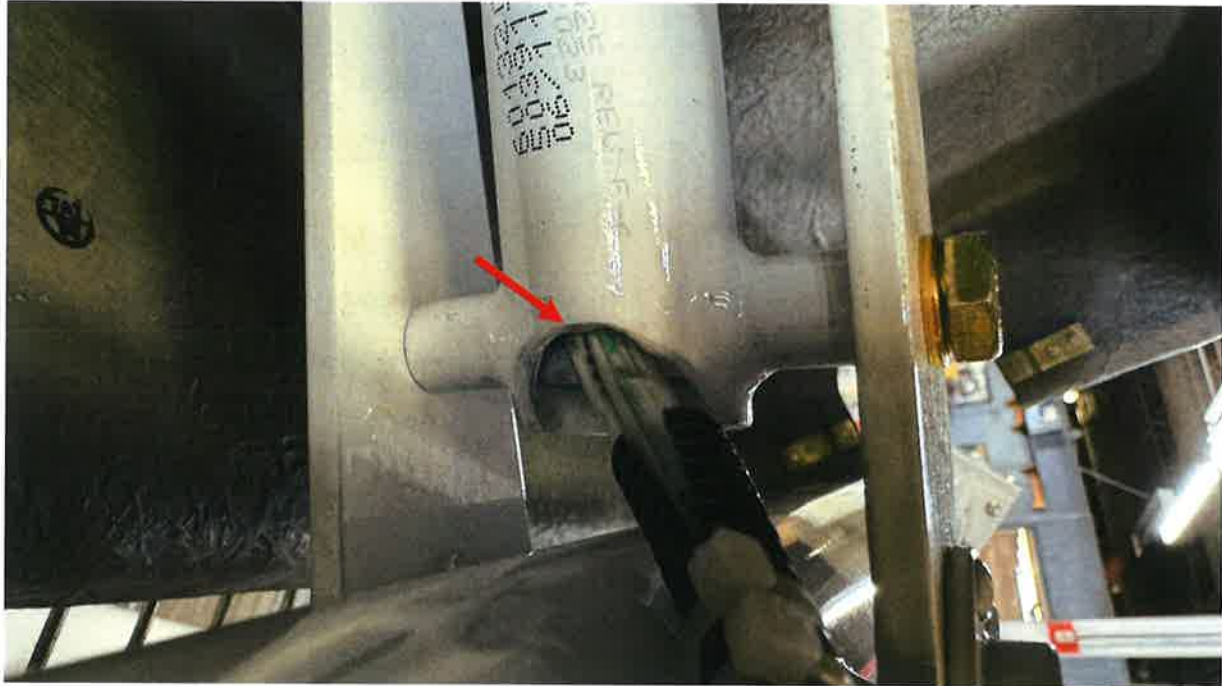
**Figure 6-2**

2. Remove the control stick grip.
3. Remove the wiring harness from the control stick.
4. Using an appropriate tool, such as a tapered rotary file, carefully remove sharp edges of control stick tube to prevent damaging wires in the future. (Reference Figure 6-2)

**Remove sharp edges ONLY. Removing excess material could compromise the control stick's integrity, increasing the risk of damage that would require replacement.**

**NOTE:** Ensure the wiring harness is routed out of the forward side of the control stick at the arched cutout as shown in Figure 6-2.
