SERVICE LETTER

SL-AG-137

Air Barrier Filter Inspection

Affected Aircraft Models	Serial Number Range
S2R-510	ALL

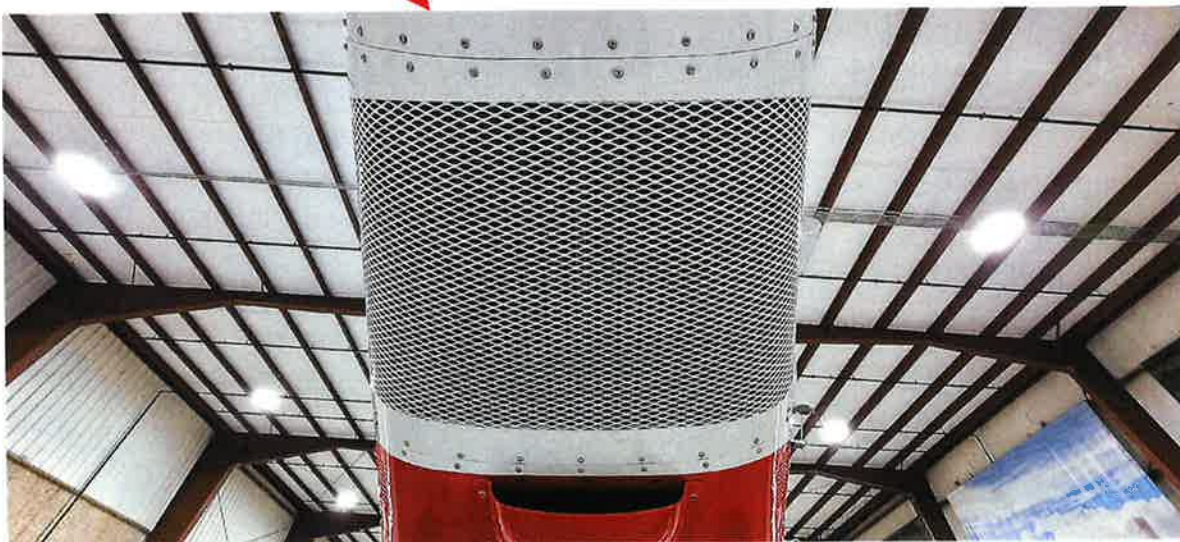
Figure 3.1

At the forward, lower side of the aircraft, remove the screws from the filter panel door then carefully lower. (Reference Figures 3.1 & 3.2)

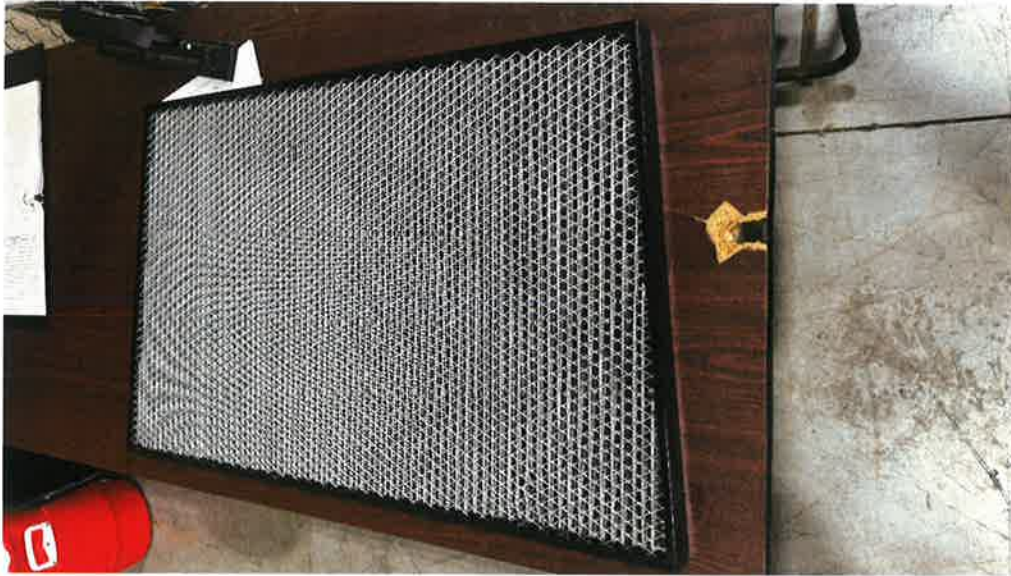
Figure 5a

1. Bring the air barrier filter to a designated work surface. (Reference Figure 5a)
