SERVICE LETTER

SL-AG-145

BARRIER AIR FILTER GAP INSPECTION

Affected Aircraft Models	Serial Number Range
S2R	Any 510-gallon series aircraft (510, H80, T34, G10) currently equipped with the 21416-009 Barrier Air Filter.

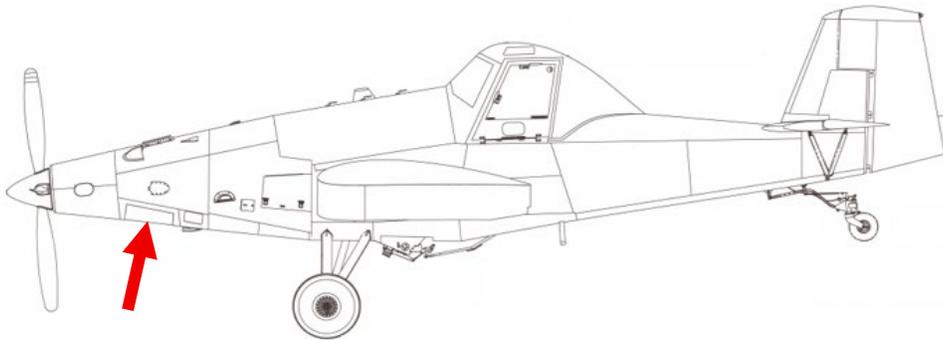
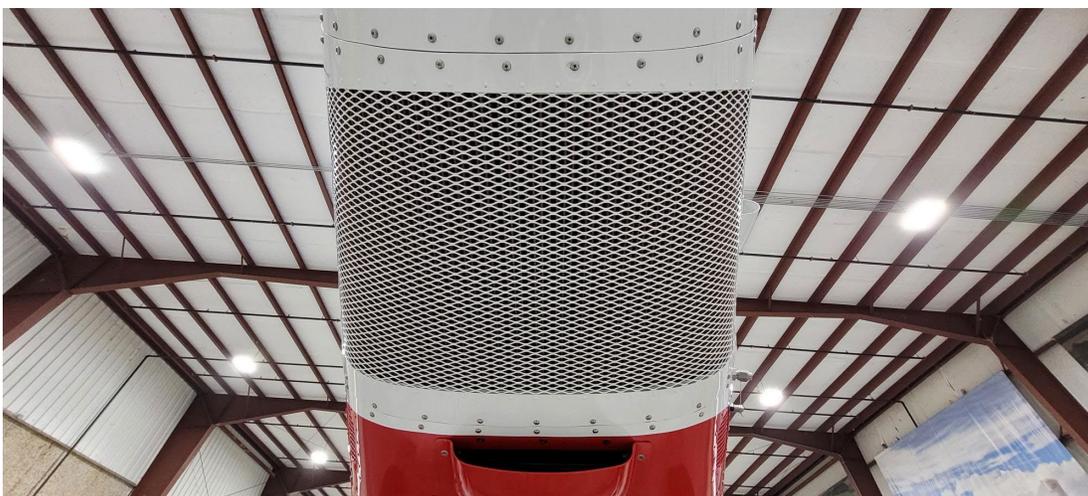
1. Locate Barrier Air Filter at forward, lower end of aircraft. (Reference Figures 1 & 2)

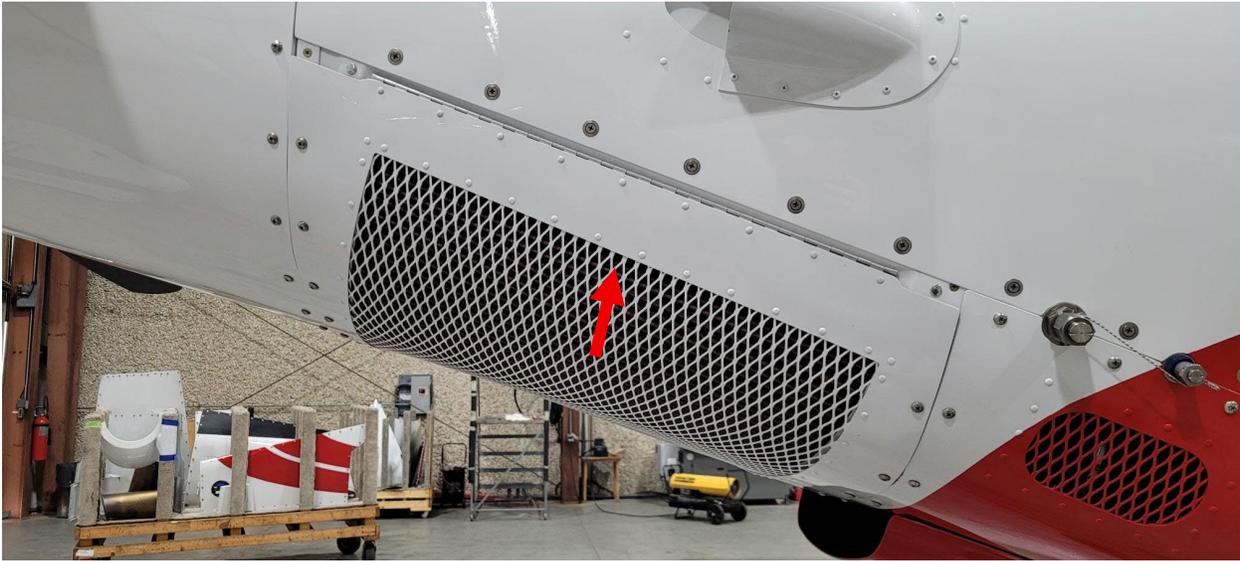
Figure 3

2. Inspect L/H and R/H sides of Barrier Air Filter for gaps. Gaps discovered if daylight visible on sides of Barrier Air Filter. (Reference Figures 3, 4, 5, & 6)

NOTE: Figures 5 & 6 show Air Filter Housing Panel open. Panel should be closed (as shown in Figures 3 & 4) during inspection.

1. If gaps found around Barrier Air Filter, notify us at support@thrushaircraft.com.

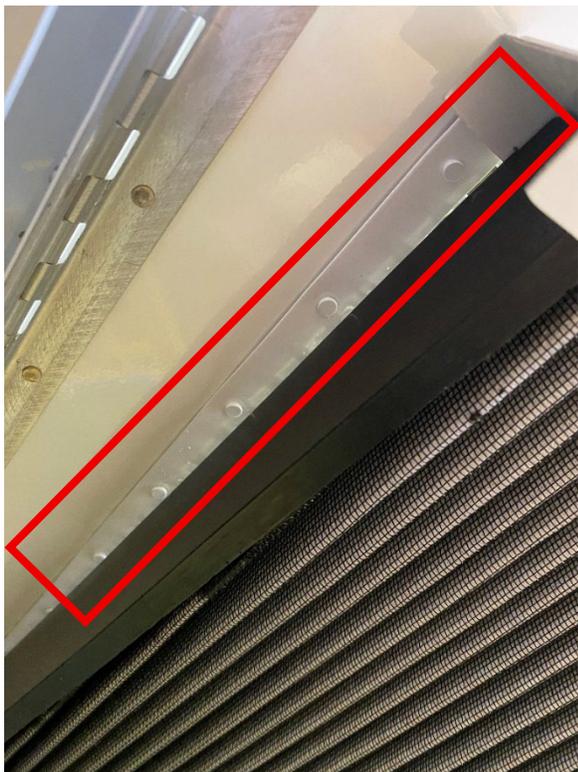
Figure 5 – LH Side, Panel Open

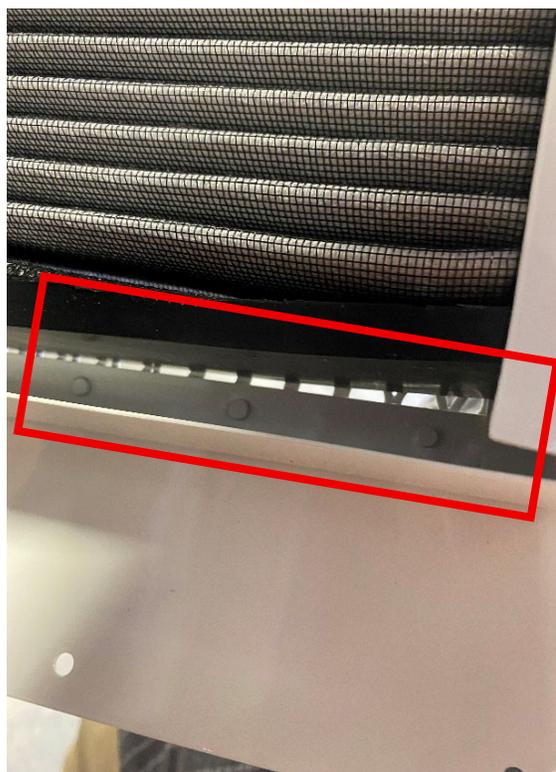
Figure 6 – RH Side, Panel Open
