# **SERVICE LETTER**

## **No. SL-AG-112**

### **Rewiring the External Power Receptacle (APU) so that the Electrical System is Energized Immediately when Power is Applied to the APU**

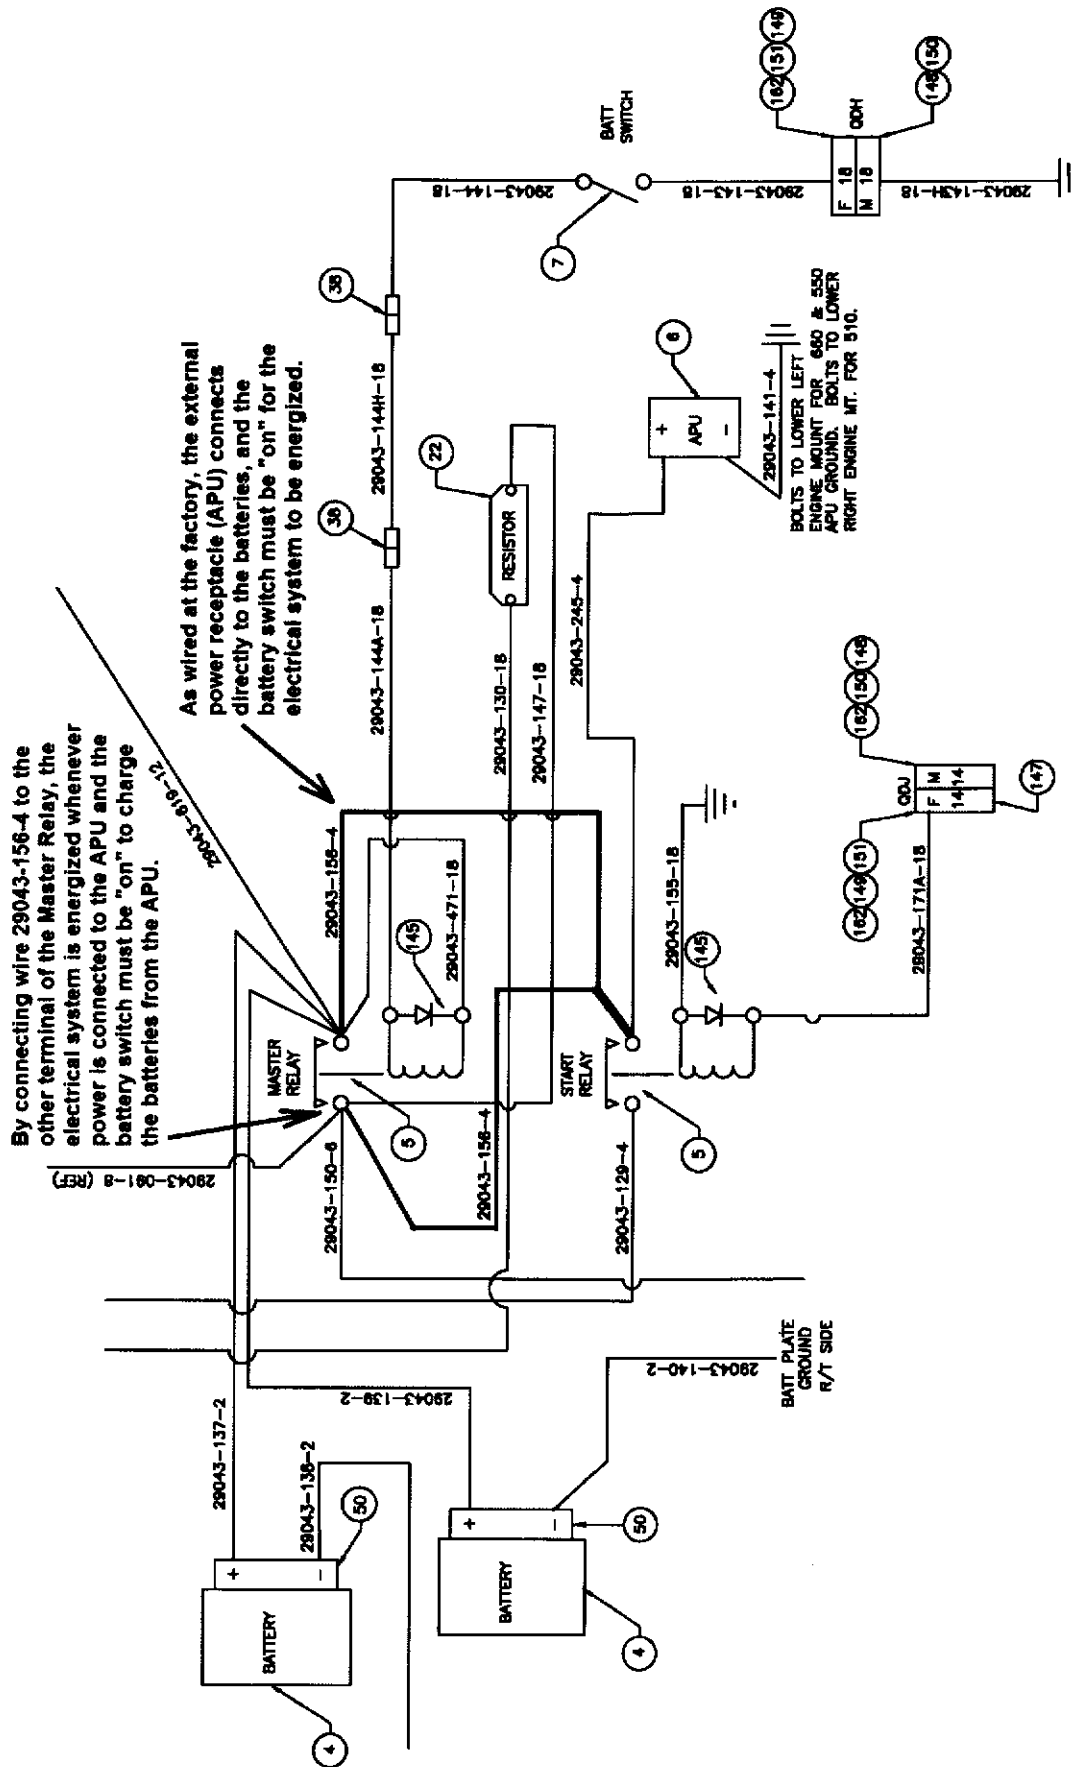
The external power receptacle (APU) of Thrushes manufactured by Thrush Aircraft, Inc. is wired such that the electrical system is energized only when the Battery Switch is activated. The batteries, however, can be charged by simply plugging electrical power into the APU while the electrical system can remain de-energized.

Some operators, however, would prefer to have the electrical system energized immediately whenever appropriate power is applied to the APU. This means, however, that in order to charge the batteries from the APU the Battery Switch must be activated, and the electrical system is energized the whole time.

The APU wiring change necessary to have the second configuration is described by this Service Bulletin.

See pages 3 & 4 of this Service Letter.

Wire 29043-156-4
