SERVICE BULLETIN

SB-AG-82

H80 PROPELLER SHAFT CARE

ENGINE – PROPELLER SHAFT – (72-10-00) – Importance of careful handling of propeller shaft during propeller's installation and removal

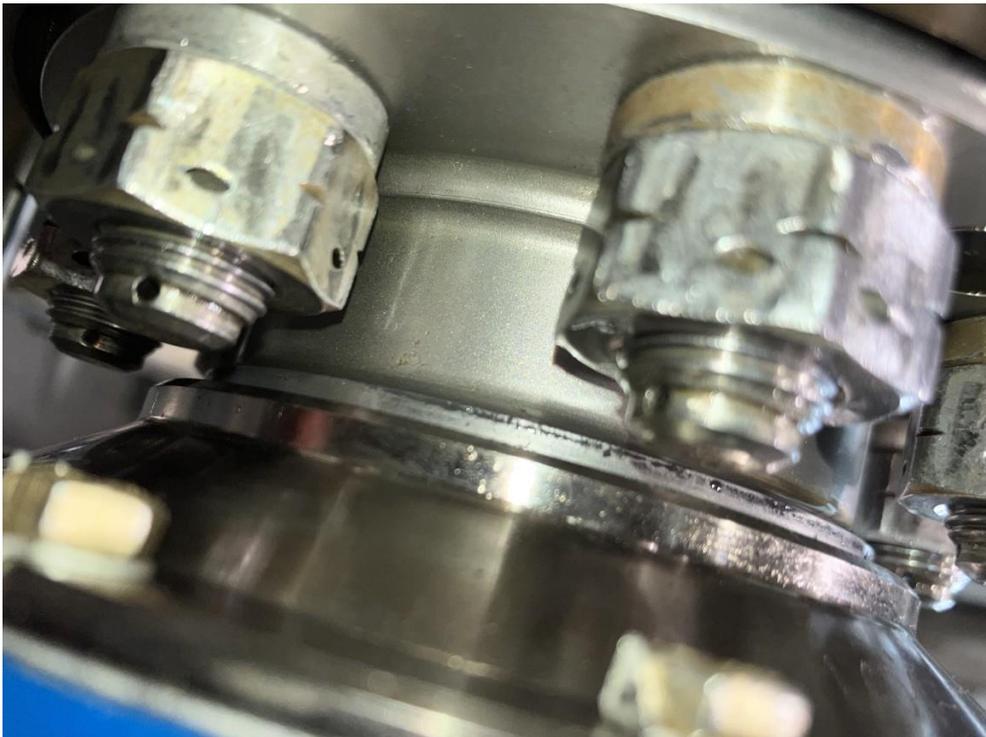
Fig. 9. View of Propeller Shaft flange with propeller nuts and washers installed.

Refer to propeller manufacturer’s manual for a list of the recommended tools.
