# SERVICE BULLETIN

SB-AG-85

## 510 Gallon Series Tail Spring Forward Mount Support Struts Installation

Affected Aircraft Models	Serial Number Range
S2R-T34, S2R-H80, S2R-G10, R1340 S2R-510	ALL 101-145 & 501-528

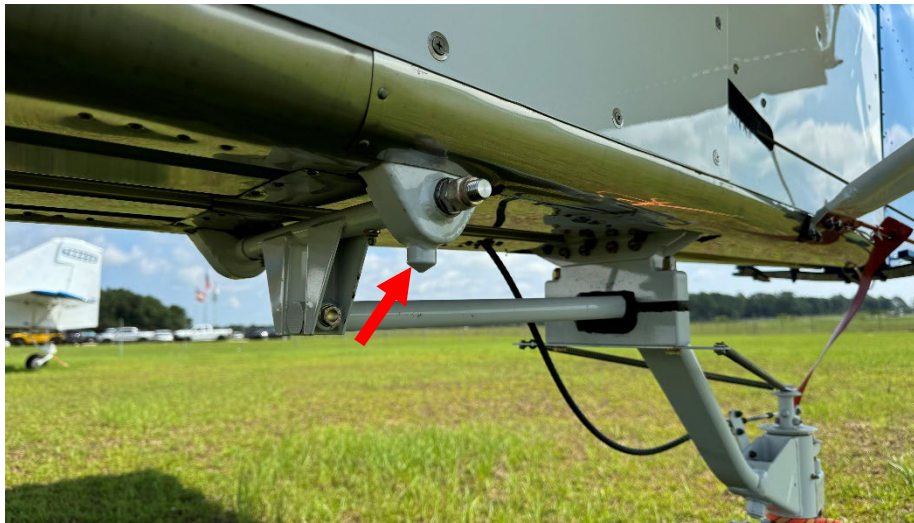
**Figure 8.1 Jack Point Location**

When using the jack points to lift the aircraft, all hopper loads should be removed. A jack point is provided on the tail wheel trunnion attach fitting on the lower left longeron. (Reference Figure 8.1)

1. Chock the forward main landing gear wheels.
2. Place an appropriate jack at the aft jack point of the aircraft and carefully raise the aircraft enough to give plenty of ground clearance to remove the tail gear assembly.

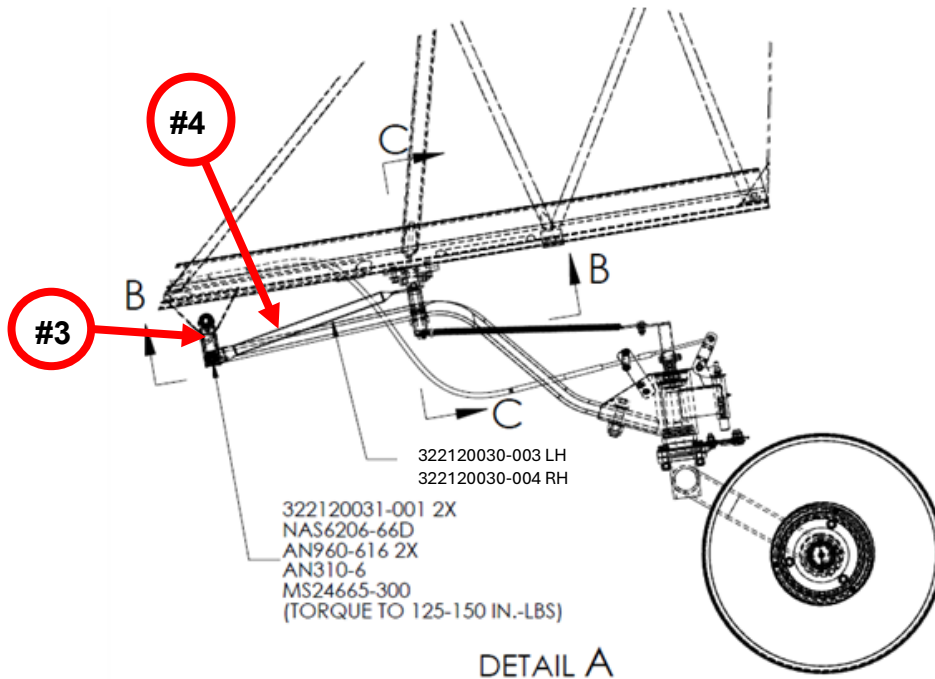
**Figure 11.1 Tail Wheel Installation Diagram**

\*\*\* Note that the position of the trunnion is not perpendicular as shown above but should be perpendicular or slightly forward when on the ground level. \*\*\*

4. Locate and loosely install tail spring, struts, upper and lower support blocks and spacers, and hardware per Figures 11.1, 11.2, & 11.3.

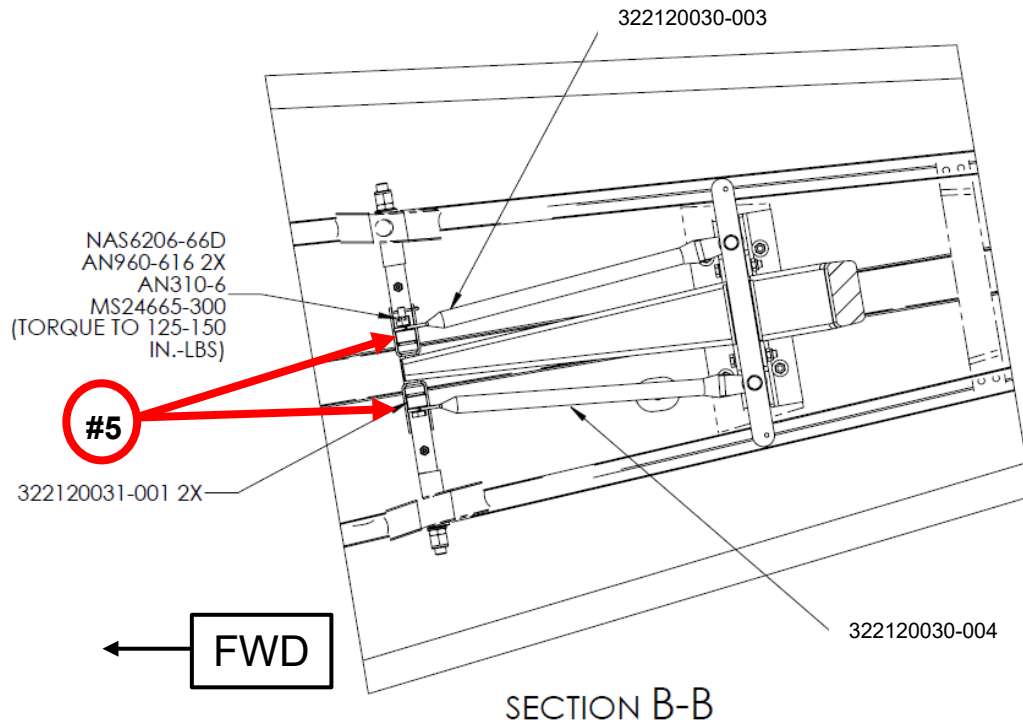
**Figure 11.3 Fwd Tail Mount Struts Installation  
(View Looking Up Under Belly Skin)**

Thrush Aircraft has been notified by one or more owners/operators of slippage of the tail spring forward mount on our 510 gallon series aircraft.

**NOTE:** Loosen fwd trunnion so that it can be rotated aft until aligned with struts. Loosely install bolt through struts, bushings, washers, and trunnion. Fwd trunnion should be retorqued only after struts have been torqued.

5. Torque the fwd mount bolt (P/N: NAS6206-66D) to 125-150 inch-pounds then install cotter pin. (Reference Figure 11.3)

**NOTE:** DO NOT TORQUE NUT BEYOND MAXIMUM TORQUE RANGE. DISCARD ANY BOLTS THAT ARE OVERTORQUED.
